REPORT No 11671

ISO 9227

SALT SPRAY TEST

Program: SQO-M1 Round 15

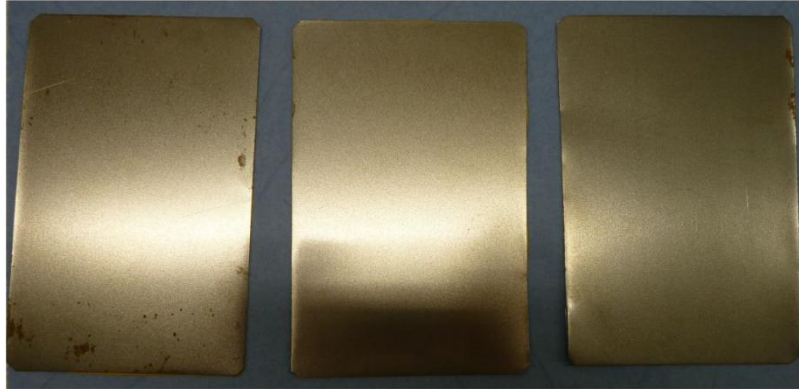
Before testing

OBSERVATIONS
<p>Sample LM3514 presents traces of rust before the testing (see photographs LM3514 before testing) M2 is after the chemical attacks</p> <p>Sample LM3721 : As the FSC is very difficult to choose, damage on the coating has been chosen. If you want, we have more photographs of those samples and can send those to you.</p>

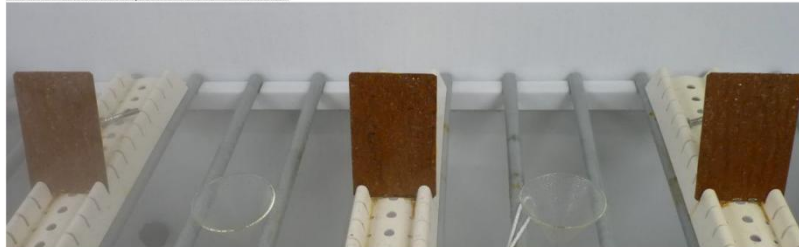
After 6h (first presence of rust)

ID	A (cm ²)	m1 (mg)	m2 (mg)	FSC (h)
LM3514-25	151,98	81,333	78,196	6
LM3514-38	147,51	80,532	77,362	6
LM3514-82	150,48	81,673	78,552	6

Laboratory Code 19: The laboratory obtained **QUESTIONABLE** results in the determination of FSC for the LM3514 batch; however, the results for the remaining parameters were **SATISFACTORY**, except for the change in mass of the LM3721 batch, which was not reported.

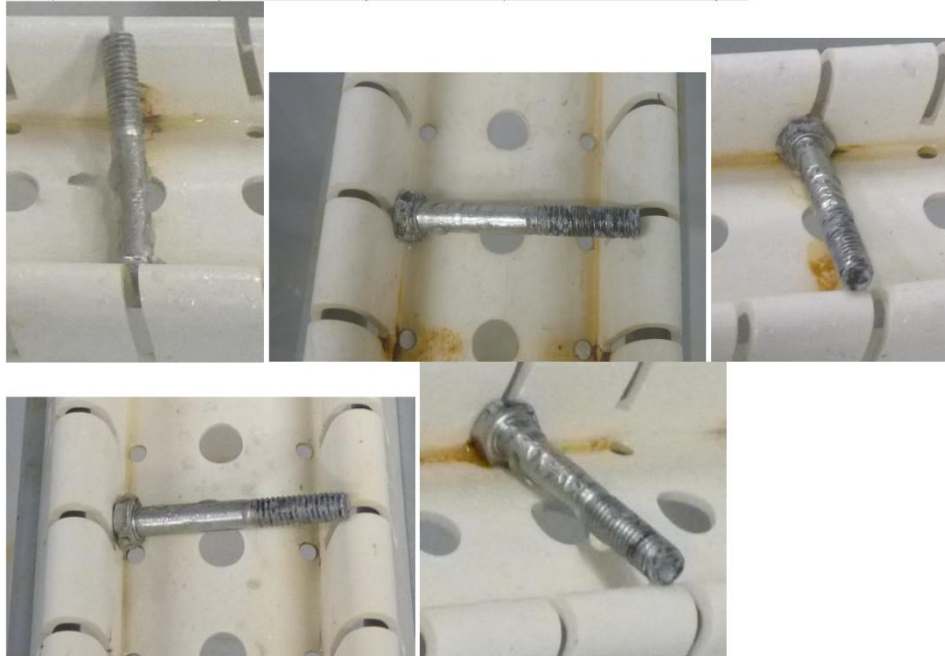
First presence of damage on the coating (1 to 5 from up to down and left to right)

ID	SAMPLE	m1 (mg)	m2 (mg)	FSC (h)
LM3721-19	I	/	/	19
	II	/	/	30
	III	/	/	19
	IV	/	/	6
	V	/	/	19
