# REPORT No 11291-AMD1

## NACE TM 0284

## EVALUATION OF PIPELINE AND PRESSURE VESSEL STEELS FOR RESISTANCE TO HYDROGEN-INDUCED CRACKING

### Program: SQO-M4 Round 17

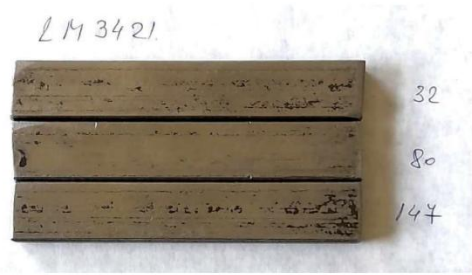
PHOTOGRAPHS	
<b>Solution A</b>	<b>Solution B</b>
LM3421- 32// 80 // 147	LM3428 - 24 // 82 // 139
Surface pattern after NACE TM 0284 test	Surface pattern after NACE TM 0284 test

SAMPLE	SECTION	RESULTS (%)		
		CSR	CLR	CTR
<b>LM3421-32</b>	I	0.4734	0.8724	0.0041
	II	1.6833	2.3991	0.0404
	III	1.4203	2.6172	0.0189
<b>LM3421-80</b>	I	0.0000	0.0000	0.0000
	II	0.0000	0.0000	0.0000
	III	0.0000	0.0000	0.0000
<b>LM3421-147</b>	I	0.0000	0.0000	0.0000
	II	0.0000	0.0000	0.0000
	III	0.0000	0.0000	0.0000
<b>MEAN</b>		0.3975	0.6543	0.0070

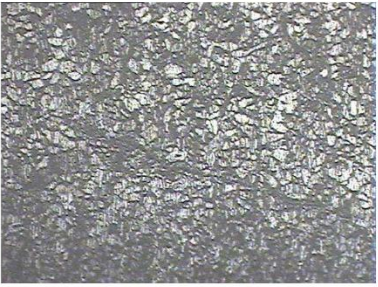
LM3421-32	LM3428-24
Microstructure of sample 32 Magnification x 100	Microstructure of sample 24 Magnification x 50

OBSERVATIONS
<p>Alumina (Al<sub>2</sub>O<sub>3</sub>) suspension of 0,3 µm was used to prepare by polishing the samples surfaces up to mirror brightness before optical microscope investigation. The samples tested in NACE solution A before microstructure analysis were etched with Nital solution (5 ml HNO<sub>3</sub> : 95 ml etanol) for 15 seconds.</p>

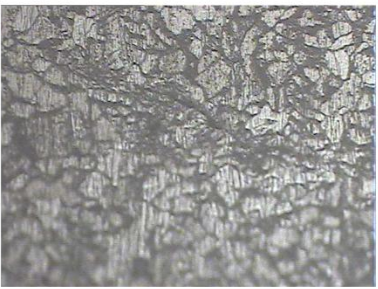
Microstructure of sample 32 Magnification x 200	Microstructure of sample 24 Magnification x 100

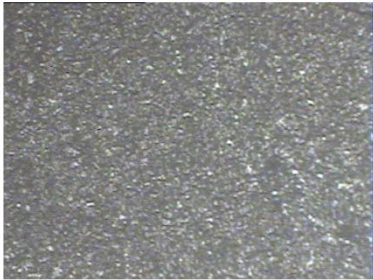
LM3421- 80	LM3428-82
Microstructure of sample 80 Magnification x 50	Microstructure of sample 82 Magnification x 50

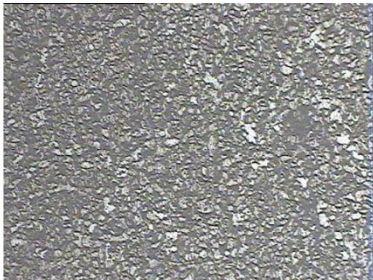
Microstructure of sample 80 Magnification x 100	Microstructure of sample 82 Magnification x 100

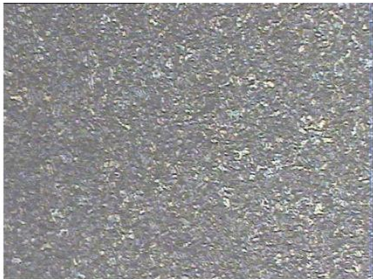
LM3421-147	LM3428-139
Microstructure of sample 147 Magnification x 50	Microstructure of sample 139 Magnification x 50

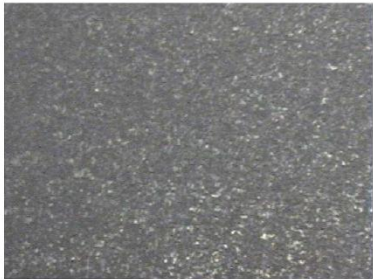
Microstructure of sample 147 Magnification x 100	Microstructure of sample 139 Magnification x 100
